Manhole Inspection Summary

Manhole # S35SS1023MH

Insp Date: **2/8/07 10:47 AM**

Location Address: **5114 NORWOOD RD**

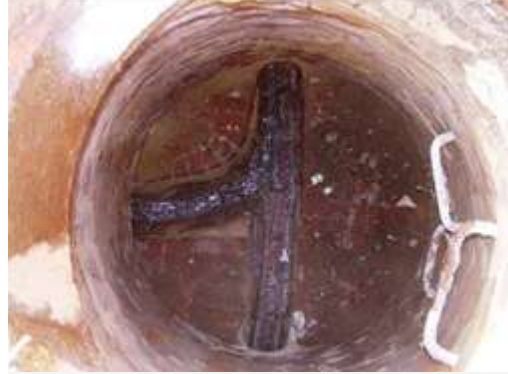
Top View

Corroded steps. Evidence of surcharge - Bench debris.

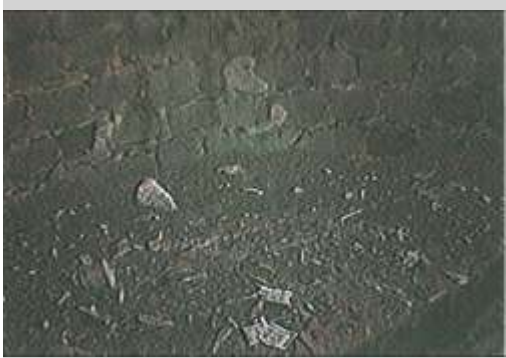
Defect

Barrel deterioration and infiltration.

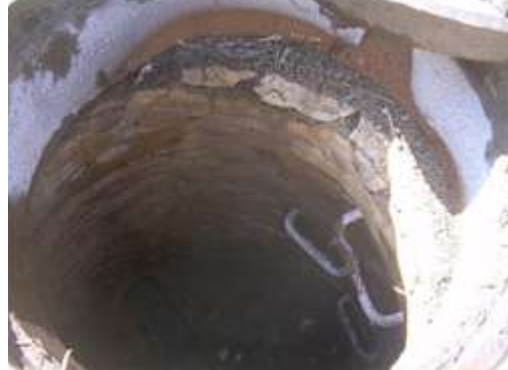
Defect

Frame leaks. Frame offset. Adjustment deterioration and infiltration. Corbel and Barrel infiltration.

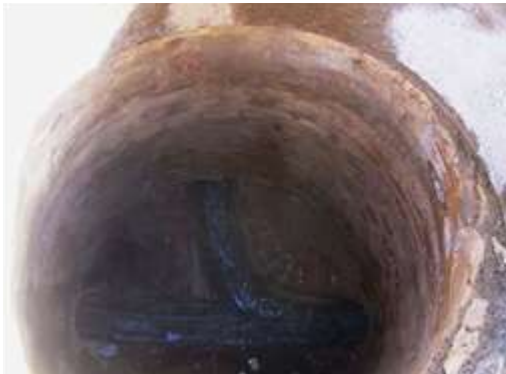
Defect

Adjustment deterioration and infiltration. Corbel and Barrel infiltration.

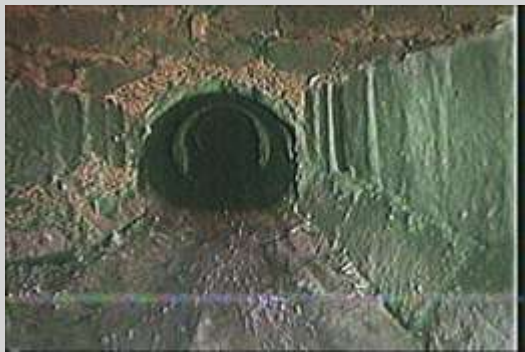
8 in. Circular Gravity Sewer Pipe Out @ 12 O'Clock

Channel deterioration.

Infiltration: **Evidence** Pipe Seal Cond: **Cracked**

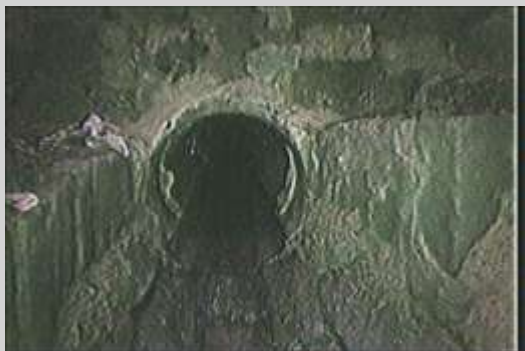
8 in. Circular Gravity Sewer Pipe In @ 6 O'Clock

Infiltration: **Evidence** Pipe Seal Cond: **Unknown**

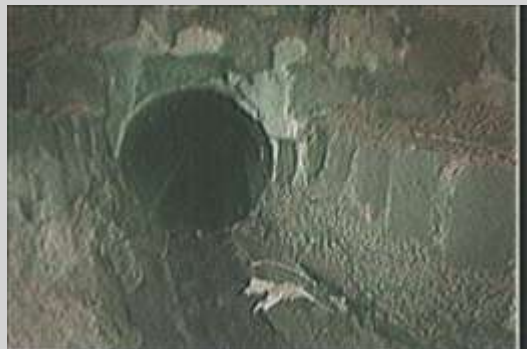
Pipe In @ 9 O'Clock

Infiltration: **Evidence**
